**SITE INSPECTION REPORT
HOLY TRINITY CEMETERY
5401 ROBERT AVENUE
LEWISTON, NIAGARA COUNTY, NEW YORK**

EPA ID No.: NYN000206698

June 2014

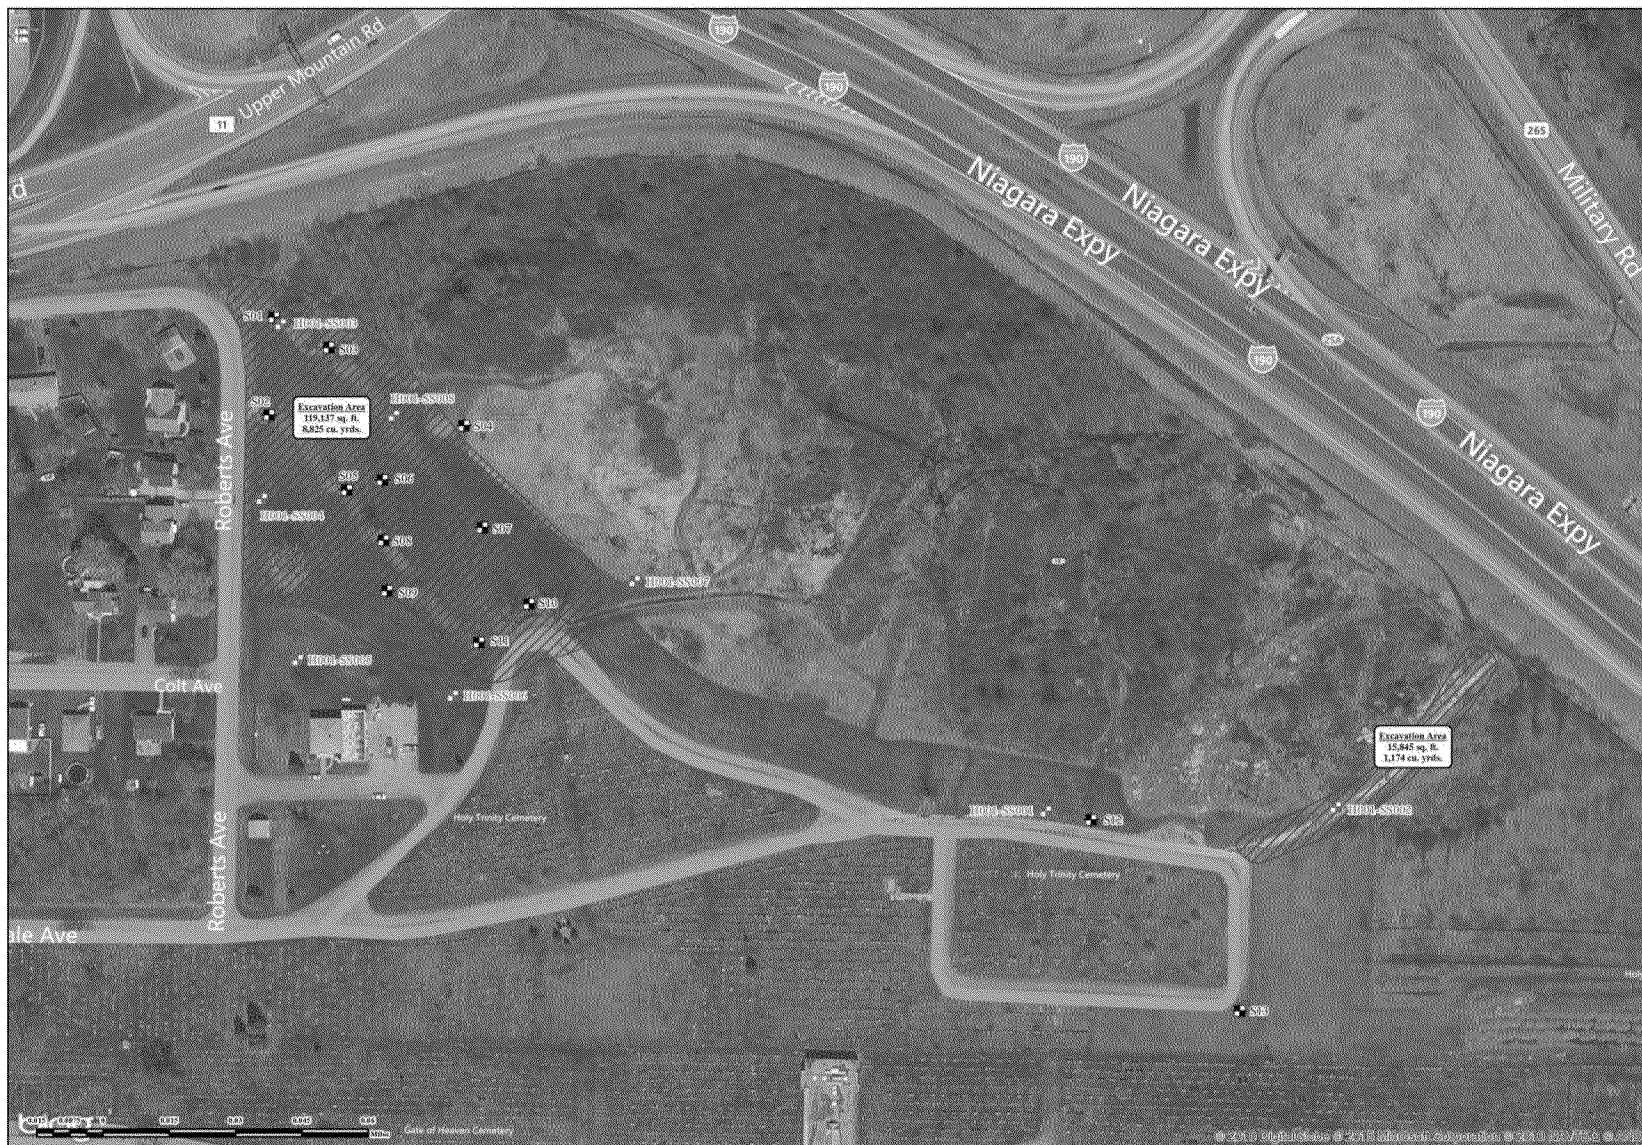
Figure 8: Site Overview and Area of Concern Map

Notes:
1.) Volume estimation based on 2 foot excavation depth.
2.) sq. ft. - Square Feet.
3.) cu. yds. - Cubic Yards.
